Appendix B

Photographs from Institutional Controls Assessment and Operation and Maintenance Inspection

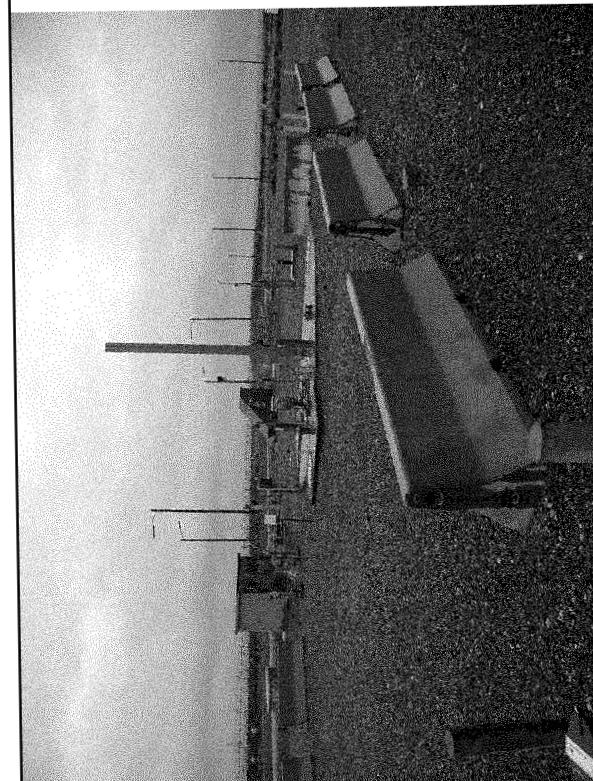
TRA-04 showing jersey barriers, 4-23-03
PD030242-06.jpg

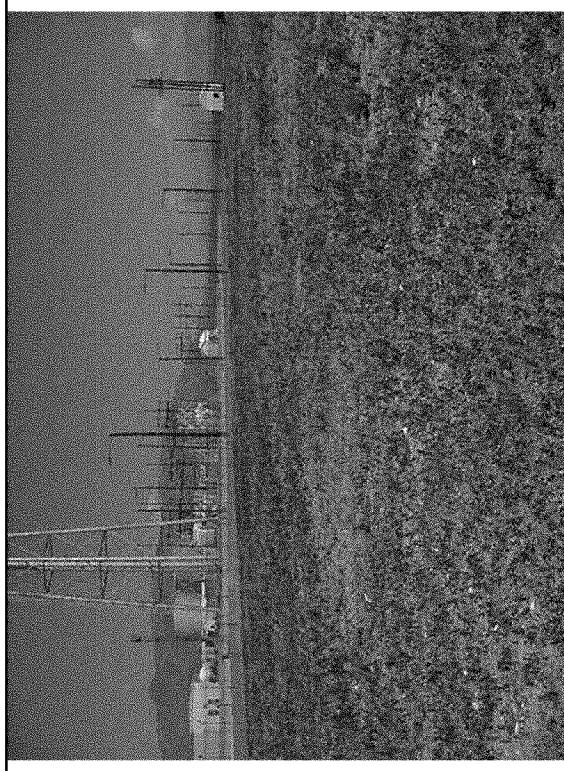
TRA-06 vegetation on 6-18-03

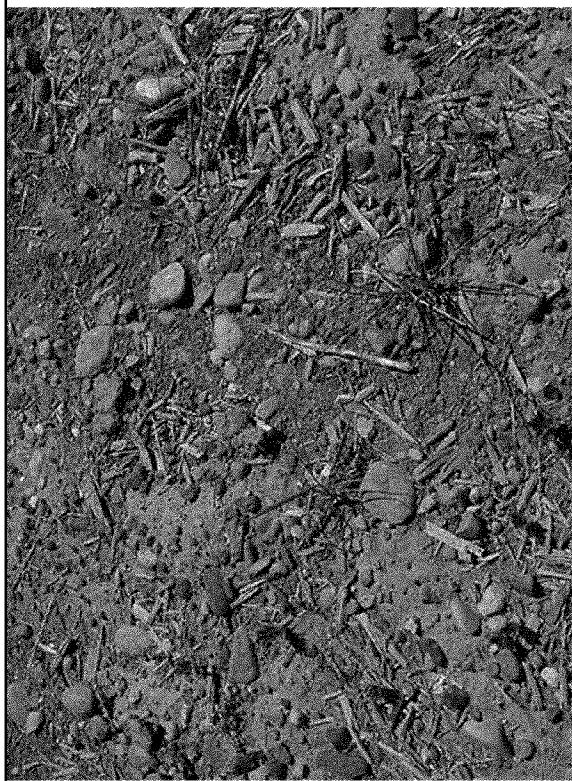
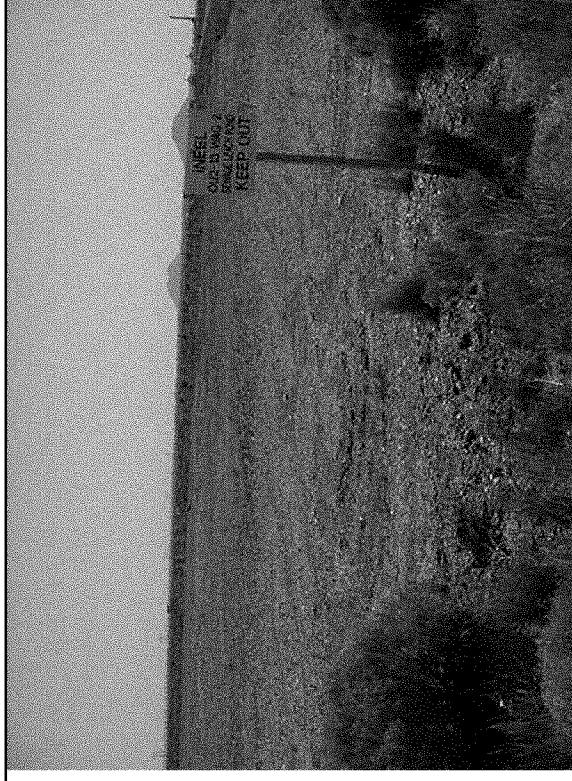
TRA-13 and SCA on 6-18-03 PD030242-12.jpg	Close-up of new growth on TRA-13 on 6-18-03 PD030242-24.jpg
